PASSAIC RIVER BASIN
FOXES BROOK, MORRIS COUNTY
NEW JERSEY

FOXES LAKE DAM

NJ 00342

**PHASE 1 INSPECTION REPORT
NATIONAL DAM SAFETY PROGRAM**

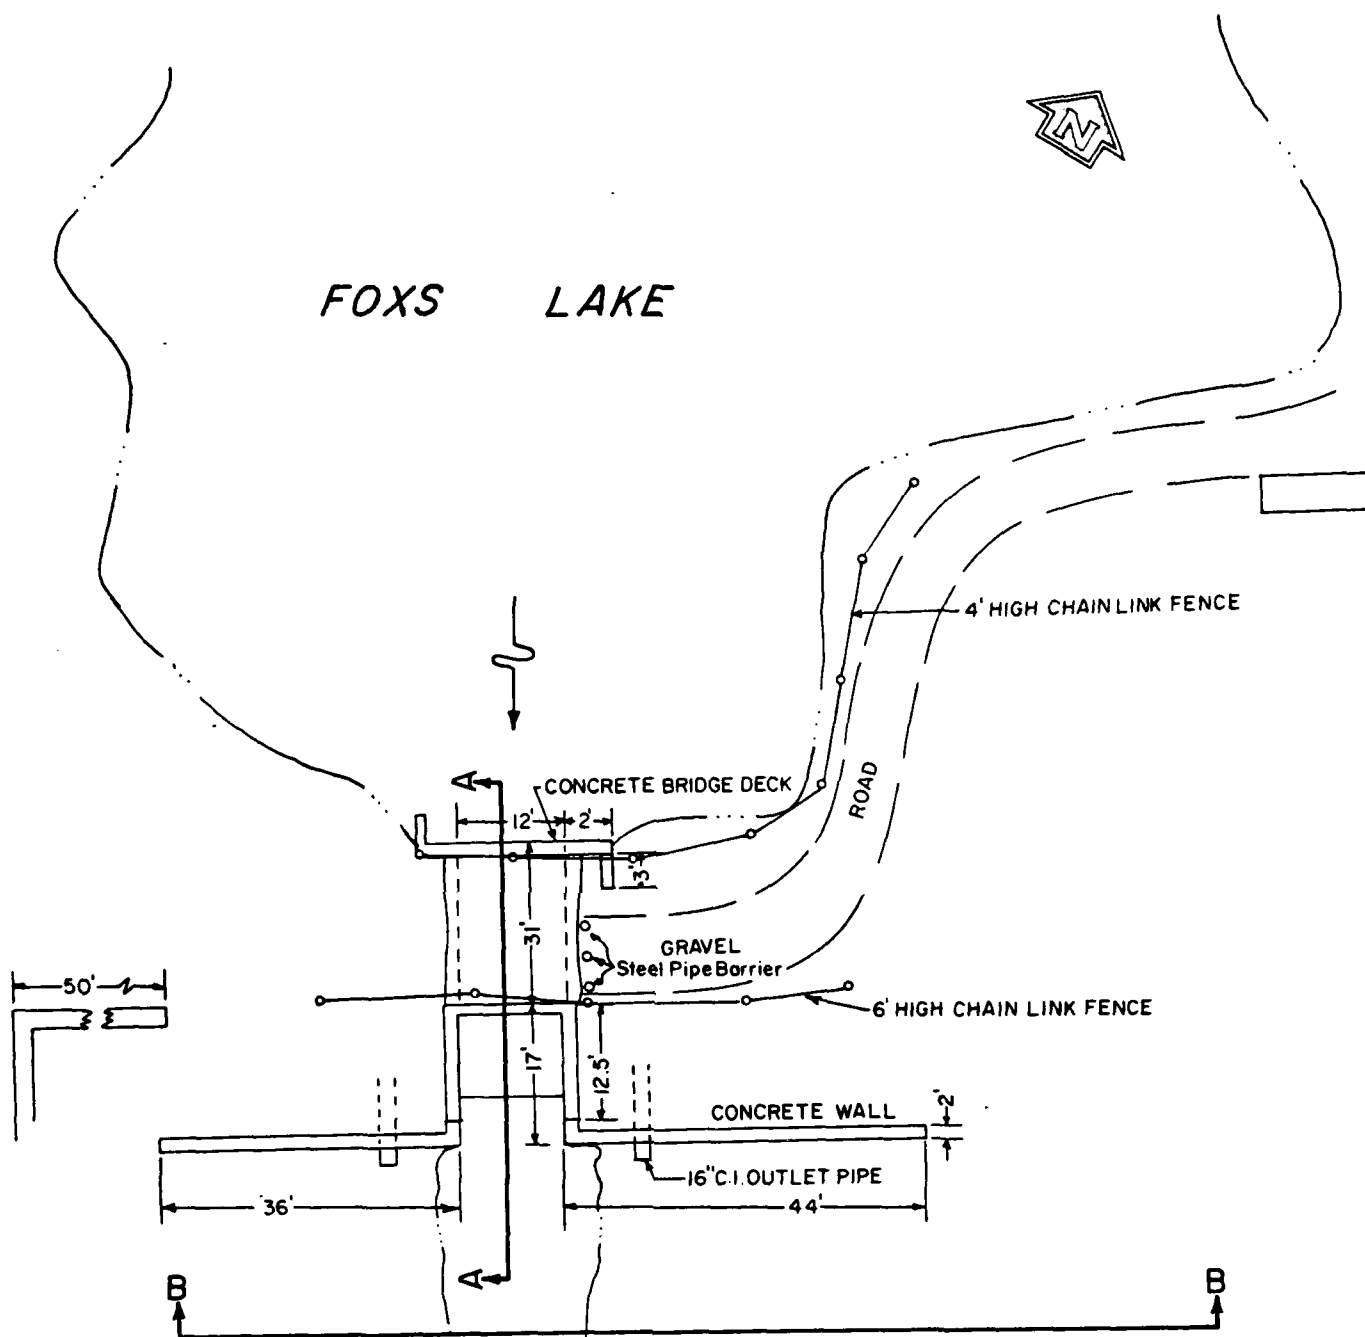
FIGURE 1

DATA FROM FIELD INSPECTION 11/9/79

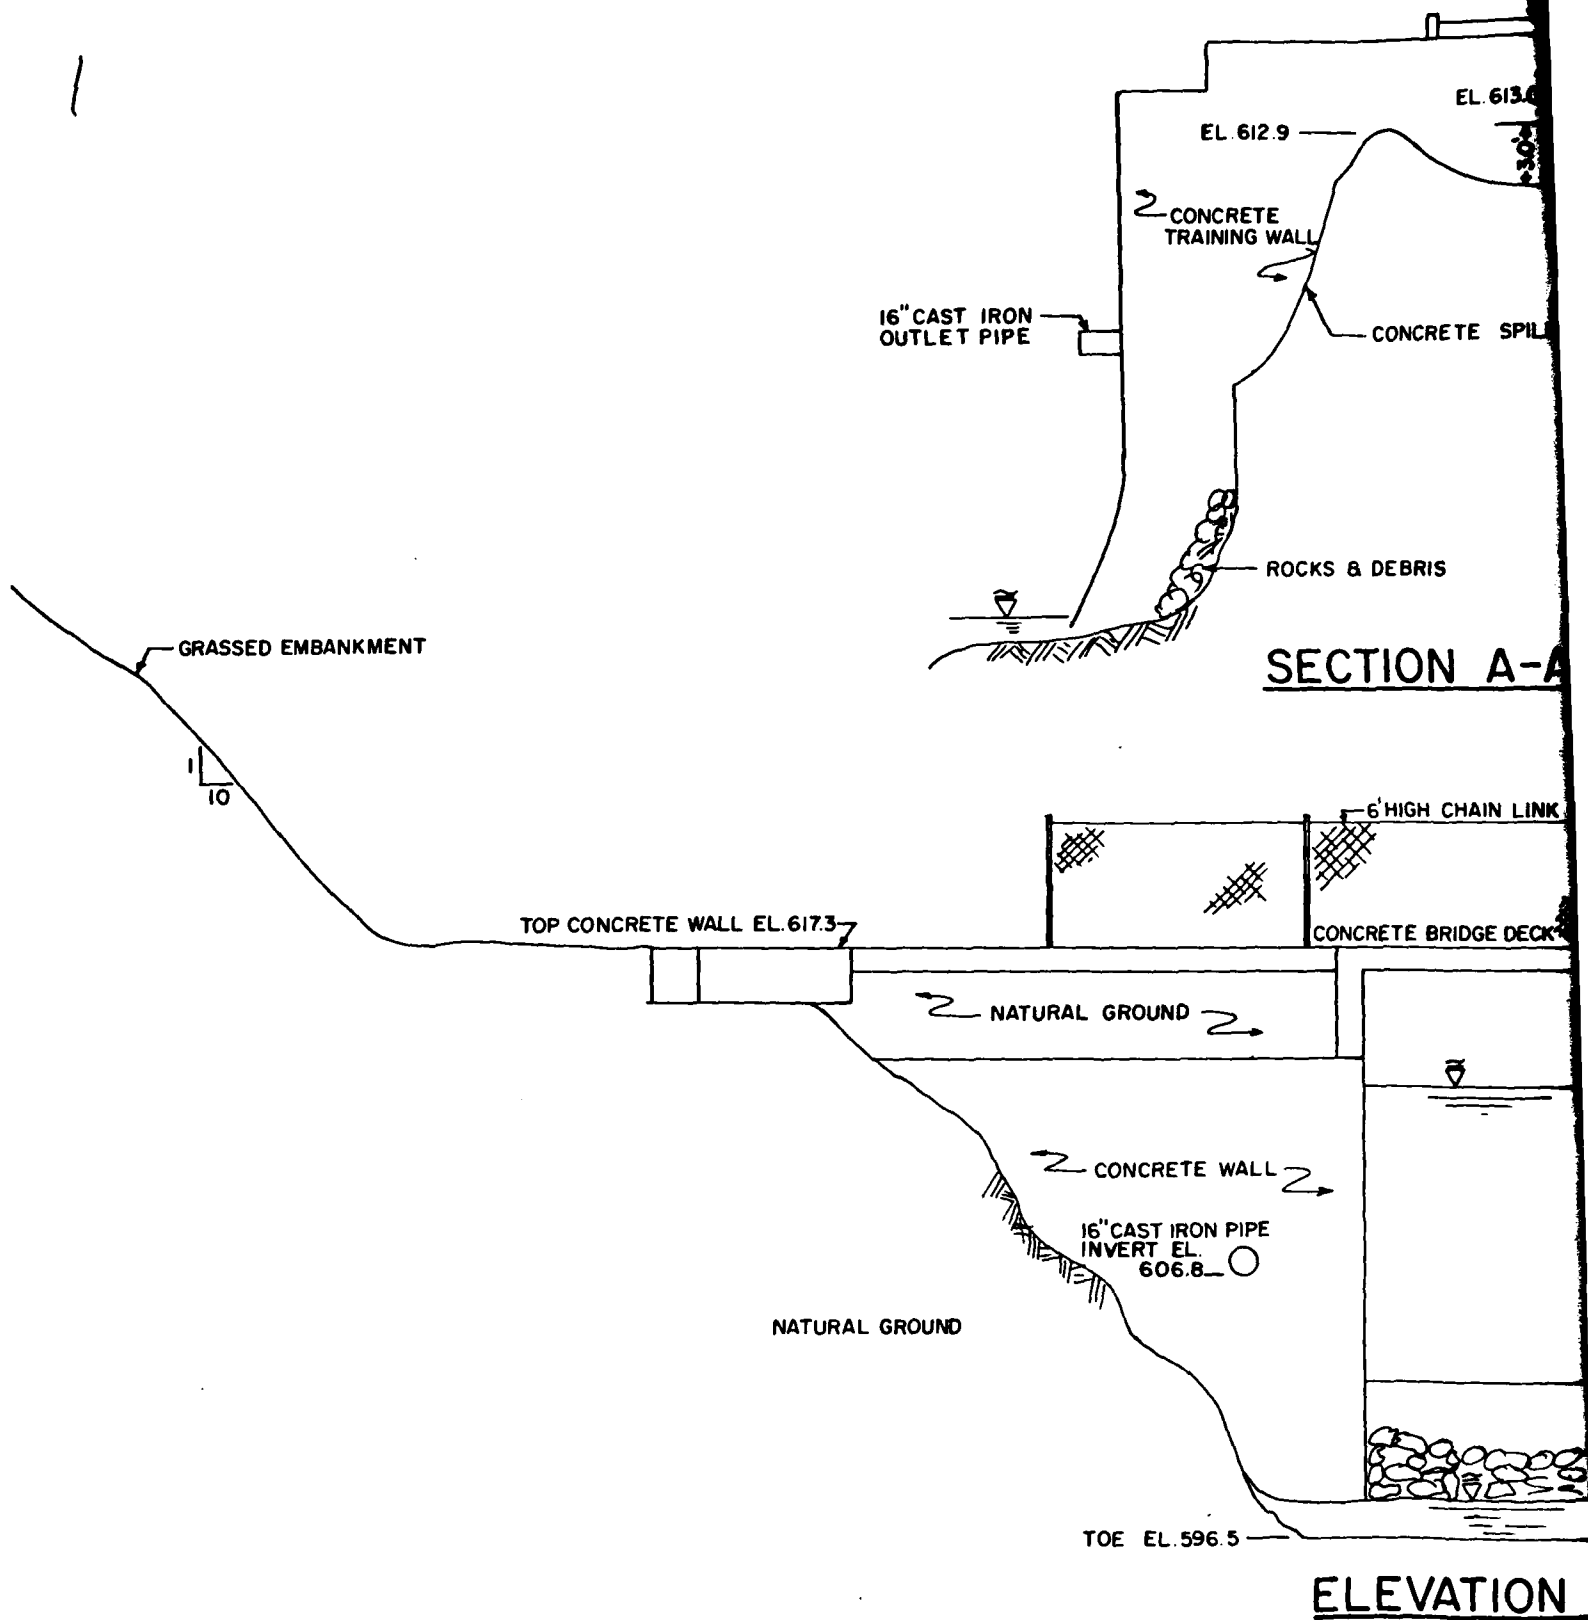
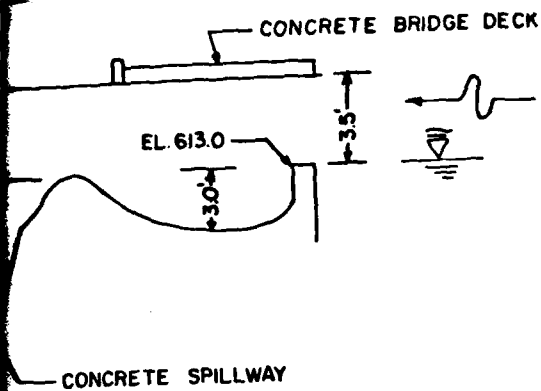
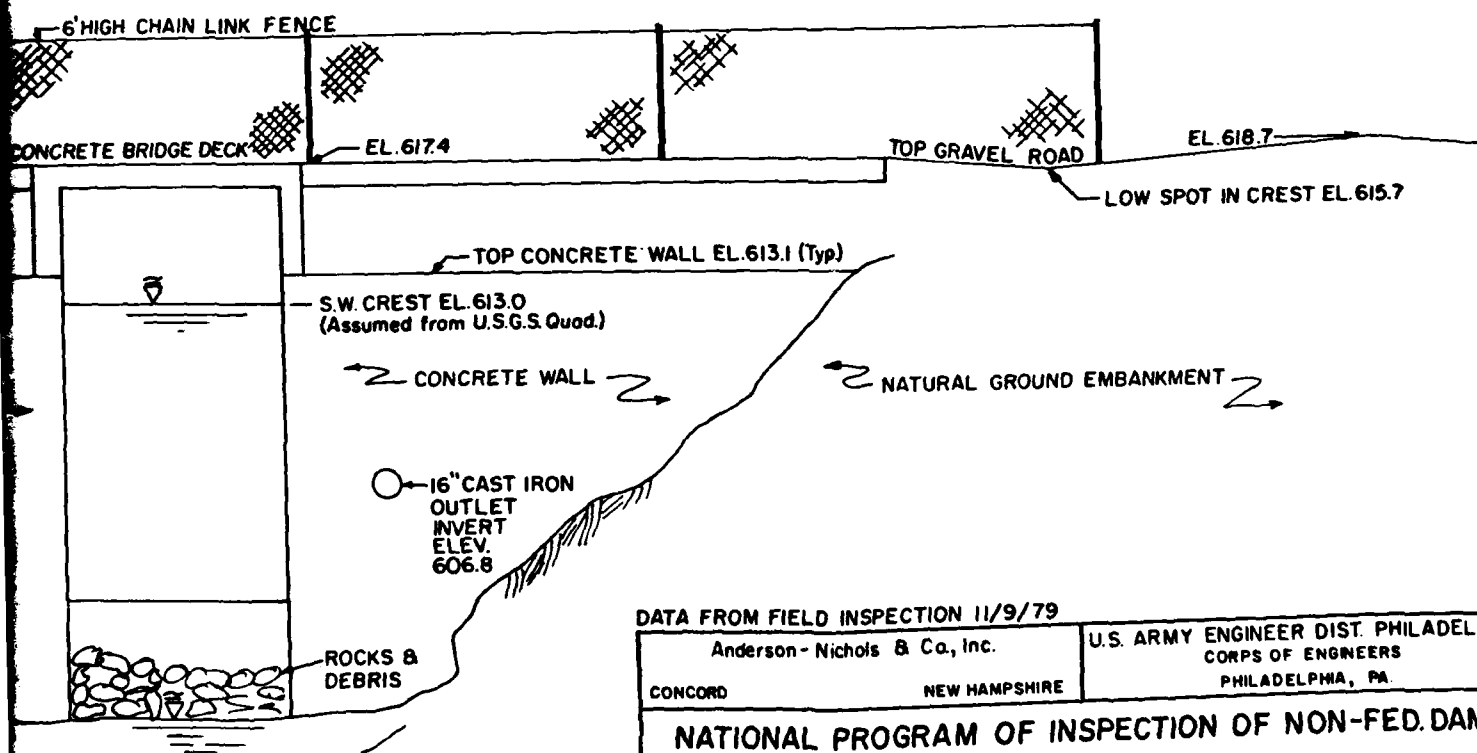
FIGURE 2

ROCKS & DEBRIS

DATA FROM FIELD INSPECTION 11/9/79		U.S. ARMY ENGINEER DIST. PHILADELPHIA	
Anderson - Nichols & Co., Inc.		CORPS OF ENGINEERS	
CONCORD		PHILADELPHIA, PA.	
NATIONAL PROGRAM OF INSPECTION OF NON-FED. DAMS			
FOXES LAKE DAM			
FOXES BROOK		NEW JERSEY	
		SCALE: NOT TO SCALE	
		DATE: JANUARY 1980
